Water Penetration Testing of an Adhered Masonry Veneer Wall Assembly

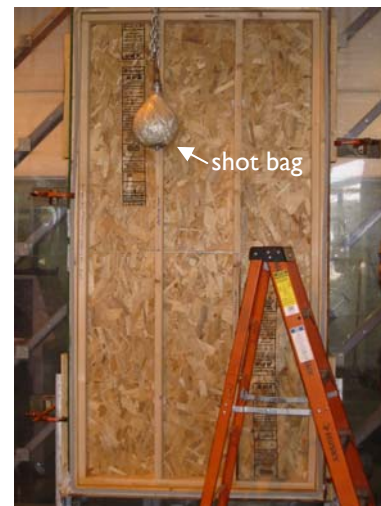
Fig. 3 – Photo showing impact of shot bag on wall's interior to create cracks in the scratch coat.

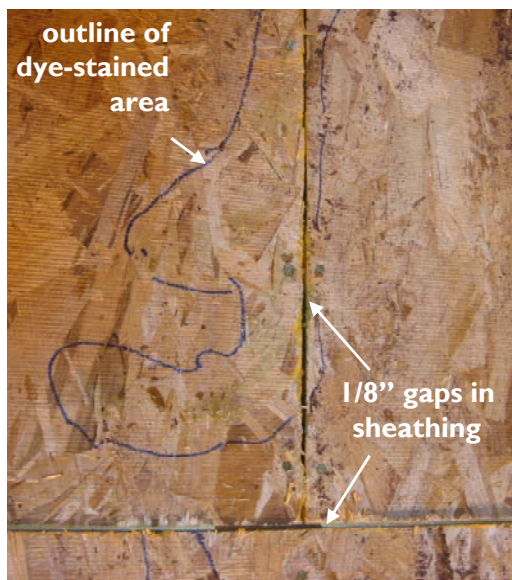
Test Result: Within minutes of initiating the test, water was observed pooling around the horizontal seam in the OSB and spilled over into a stud cavity on both assemblies. Green dye was subsequently added to the water to aid in identification of the leak source. The lath and layers of WRB were systematically removed from the test wall. It was concluded that water ran through the WRB at the lath fasteners along the vertical seams in the sheathing (Fig. 7). The vertical seams in the sheathing coincide with the framing members (Fig. 1), which are also the lath fastening locations. This common field scenario co-locates penetrations in the WRB with a direct path to the interior wall cavity, creating an opportunity for water to penetrate. No water penetration was observed at lath fastening locations that did not coincide with a sheathing gap.

Fig. 7 – Photo of sheathing after water penetration test with WRB & lath only.

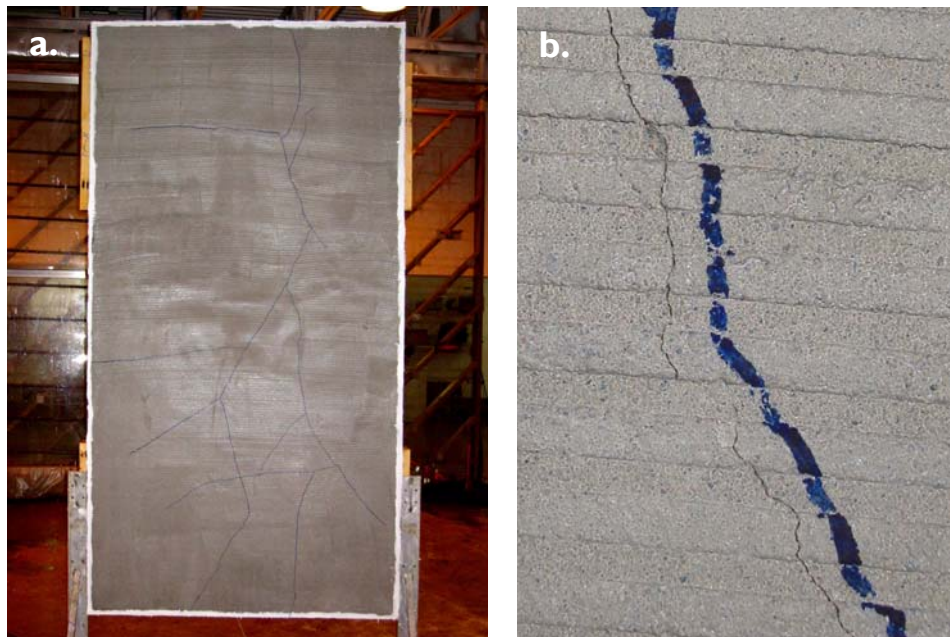
The fact that water penetration was observed with no scratch coat and was absent with a pristine scratch coat begged the question of what would happen when there were cracks in the scratch coat, as would occur upon aging. The same four assemblies were subjected to the impact described previously, which induced cracks in the scratch coat throughout each of the wall assemblies. Figure 8 shows a typical assembly, where the cracks have been highlighted with a marker. The length of visible cracks per unit area for each of the four field-of-the-wall assemblies was 4.9, 7.8, 7.8, and 9.3 inches of crack per square foot of wall area.

Test Result: No water was observed on the interior of any of these four assemblies for the 2-hour test duration.

Fig. 8 – Photo showing induced scratch coat cracking (typical) for the entire panel (a) and a close-up view (b).
