Water Penetration Testing of an Adhered Masonry Veneer Wall Assembly

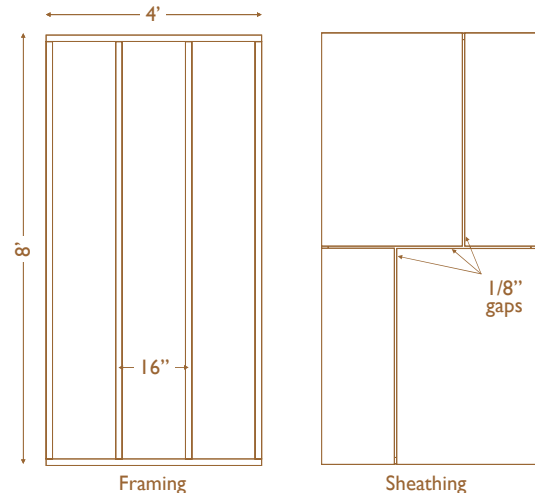
Fig. 1 – Framing & sheathing configurations.

Framing & Sheathing (without window) – Each wall assembly was 4' wide by 8' high and constructed from 2x4 wood framing spaced 16" on center (Fig. 1). The framing was sheathed with four pieces of APA-rated 1/2" oriented-strand board (OSB) – two were 32" by 48" and two were 16" by 48". These sheathing sections were secured to the wood studs in a staggered pattern with an 1/8" gap between the sheets to simulate a typical offset stacking joint (Fig. 1).

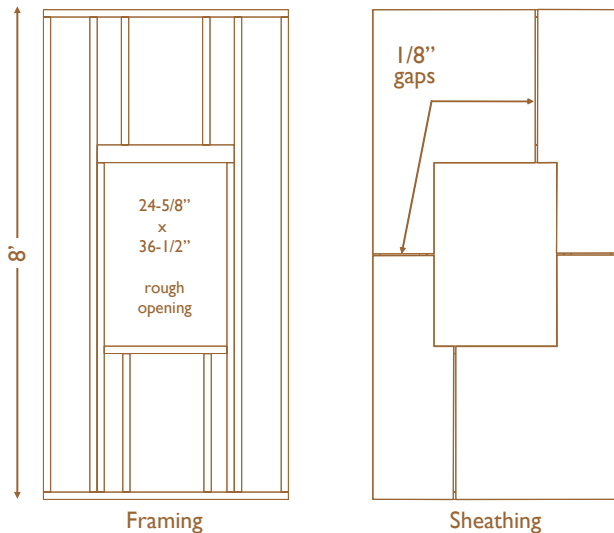
Fig. 2 – Framing & sheathing configurations with a window.

Framing & Sheathing (with window) – The wall assemblies with windows were also 4' wide by 8' high and constructed from 2x4 wood framing per the American Wood Council recommendations to accommodate a 24" wide by 36" high window (Fig. 2). The framing was sheathed with four pieces of APA-rated 1/2" oriented-strand board (OSB) separated by a 1/8" gap as shown in Fig. 2.

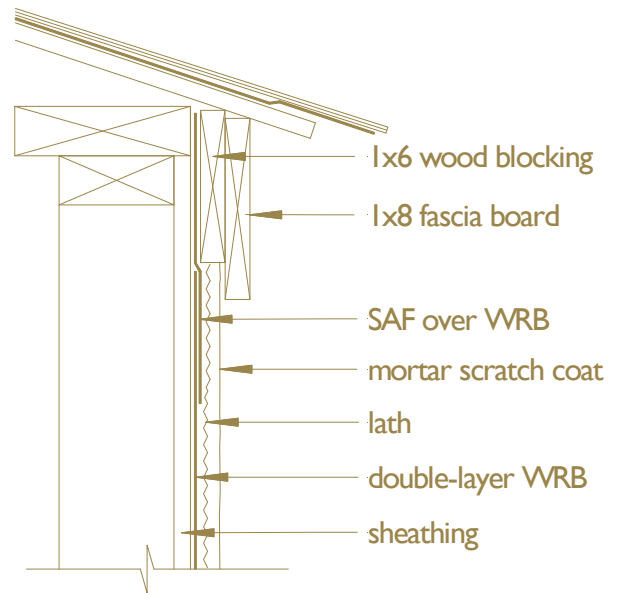
Fig. 4 – Wall/eave interface detail.

Wall / Eave Interface – The top edge of the outer-most layer of WRB was sealed to the sheathing with SAF and covered with 1x6 lumber as blocking and then a 1x8 fascia board (see Figure 4).

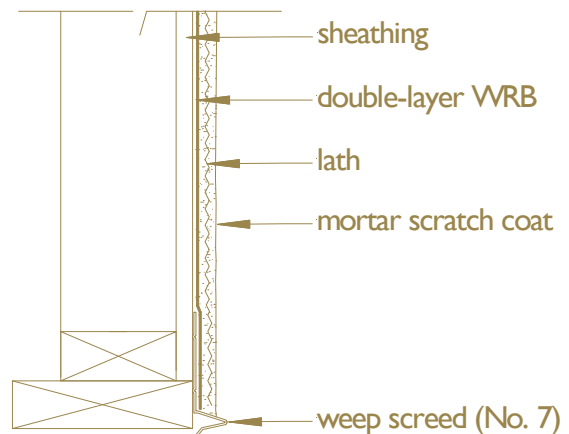
Fig. 5 – Wall sill detail.

Wall Sill (foundation termination) – The bottom edge of the wall was terminated with a foundation weep screed (No. 7), and both layers of WRB lapped over the weep screed flange (see Figure 5). No sealant, tape or SAF was used in interfacing of the weep screed with the sheathing or the interfacing of the WRB with the weep screed.

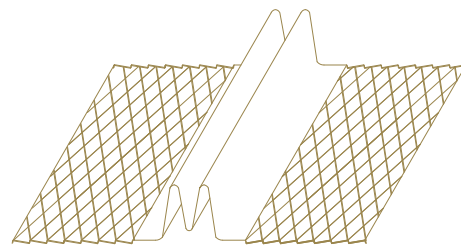
Fig. 6 – M-type expansion joint.

Control Joint – This was accomplished with an M-type expansion joint (Figure 6) located over the WRB and coincident with each seam in the OSB – one 4-foot horizontal section and two 4-foot vertical sections. No sealant was applied between the expansion joint and the underlying WRB or to any intersections in the expansion joints.
